CONNECTICUT RIVER BASIN  
LEBANON, NEW HAMPSHIRE

**MASCOMA LAKE DAM**  
**NH 00153**

**PHASE I INSPECTION REPORT**  
**NATIONAL DAM INSPECTION PROGRAM**

**MAY 1979**

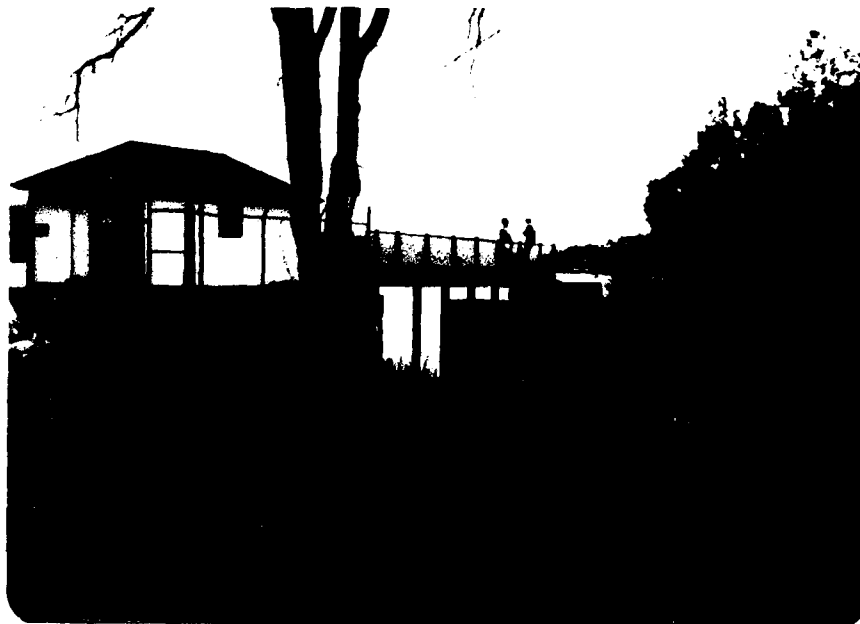
1. Mascoma Lake Dam: Gate House, Stop Log Section and Spillway.  
Footbridge from Gate House to Spillway.

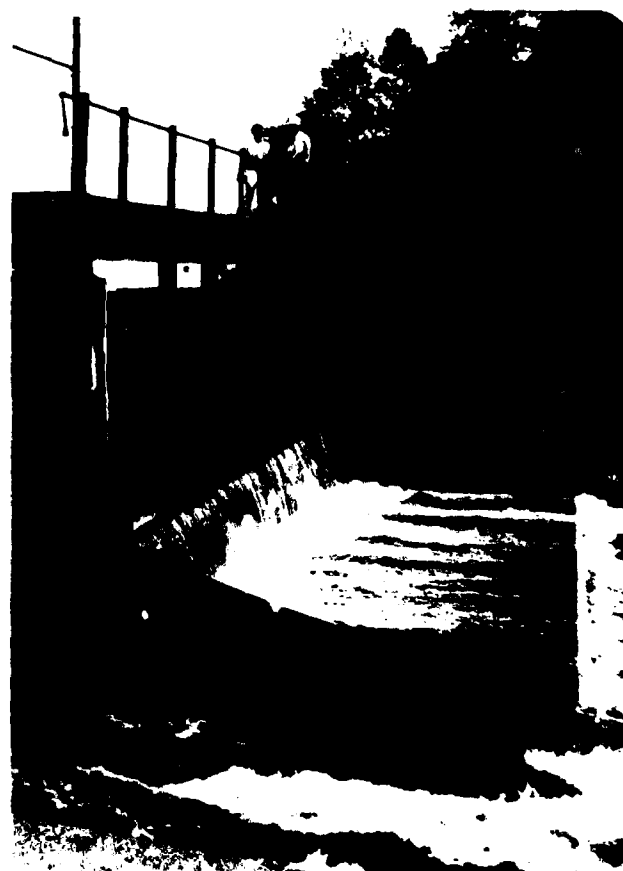
2. Stop Log Stanchions and  
Outlet. Wooden Spillway  
in Background.

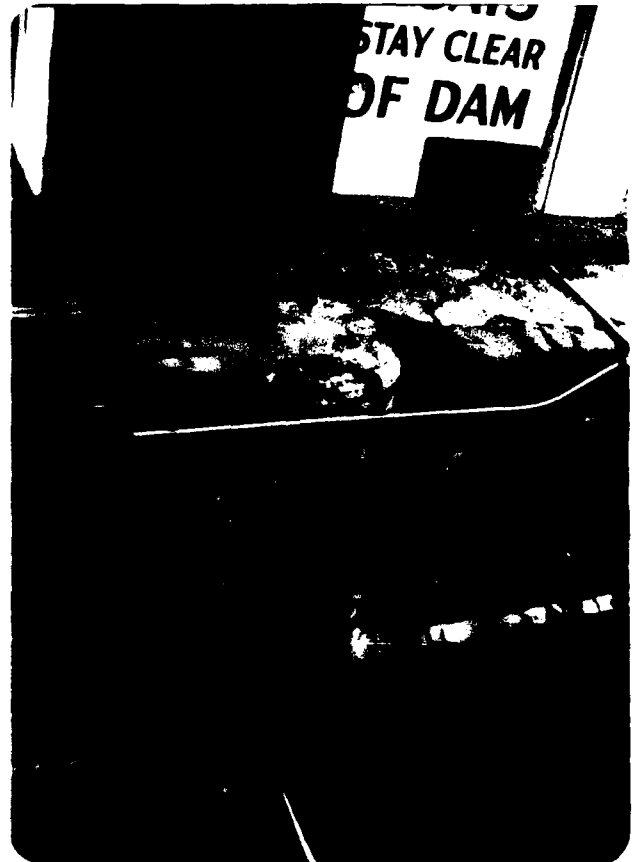
5. Intake Structure Looking from Footbridge Over Stop Log Section. Note Concrete Erosion and Surface Cracks.

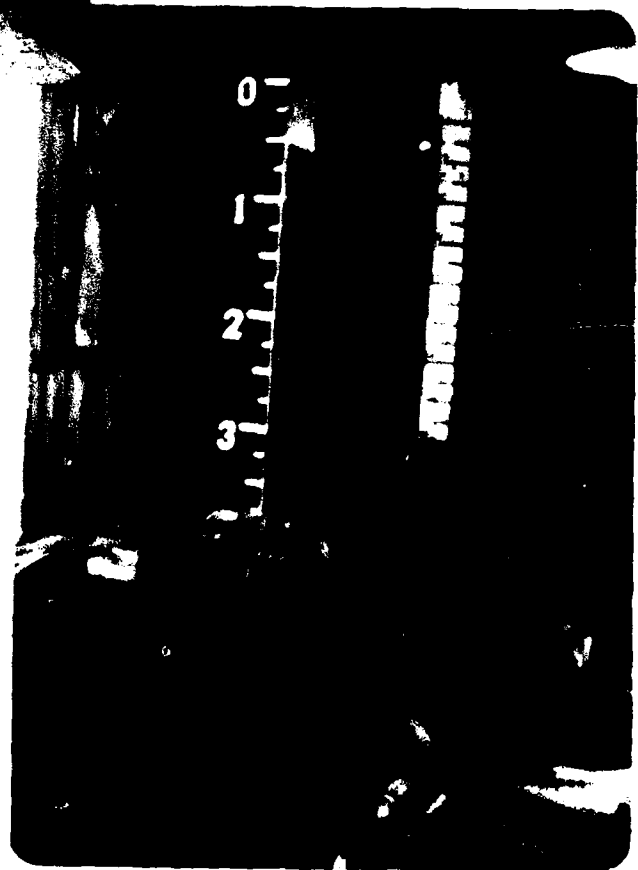
10. Inside of Gate House, Showing Operating Gear in Partially Open Position.
